Contract #: 04-0120F4Cty: SF/ALA Rte: 80 PM: 13.2/13.9File #: 69.28**WELDING INSPECTION REPORT****Resident Engineer:**Pursell, Gary**Address:** 333 Burma Road**City:** Oakland, CA 94607**Report No:** WIR-010823**Date Inspected:** 14-Dec-2009**Project Name:** SAS Superstructure**OSM Arrival Time:** 645**Prime Contractor:** American Bridge/Fluor Enterprises, a JV**OSM Departure Time:** 1900**Contractor:** Zhenhua Port Machinery Company, Ltd (ZPMC), Changxing Island **Location:** Shanghai, China**CWI Name:** Li yang**CWI Present:** Yes No**Inspected CWI report:** Yes No N/A**Rod Oven in Use:** Yes No N/A**Electrode to specification:** Yes No N/A**Weld Procedures Followed:** Yes No N/A**Qualified Welders:** Yes No N/A**Verified Joint Fit-up:** Yes No N/A**Approved Drawings:** Yes No N/A**Approved WPS:** Yes No N/A**Delayed / Cancelled:** Yes No N/A**Bridge No:** 34-0006**Component:** OBG Components**Summary of Items Observed:**

TRAIL ASSEMBLY

WELDING INSPECTION REPORT

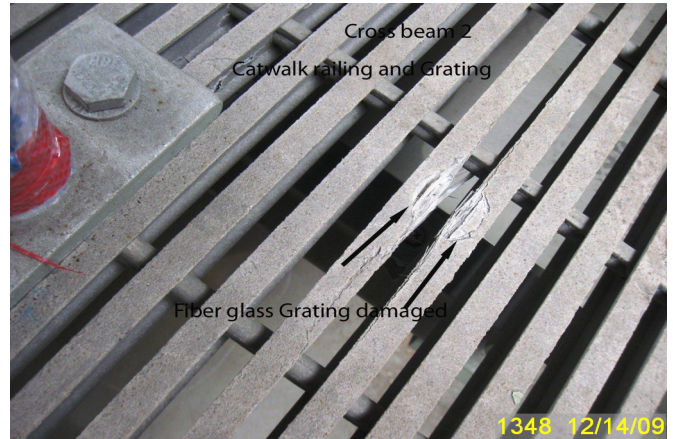
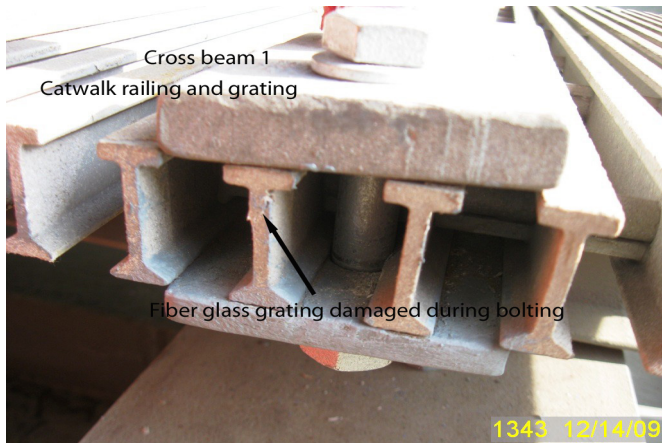
Catwalk rail and grating under FL3 -Lift 2 (west) – Washer on top side is not seated properly because of nearby fillet weld, so that both washers put on bottom side . ZPMC QA Mr.Laytao present. Informed to CT Mr.Mark miller for further action.

Catwalk rail and grating- CB1,CB2-Fiber glass grating damaged.
